UNDERSTANDING EXTRACTIVE BLEED

Joint Coatings/Forest Products Committee;
Extractives Task Force

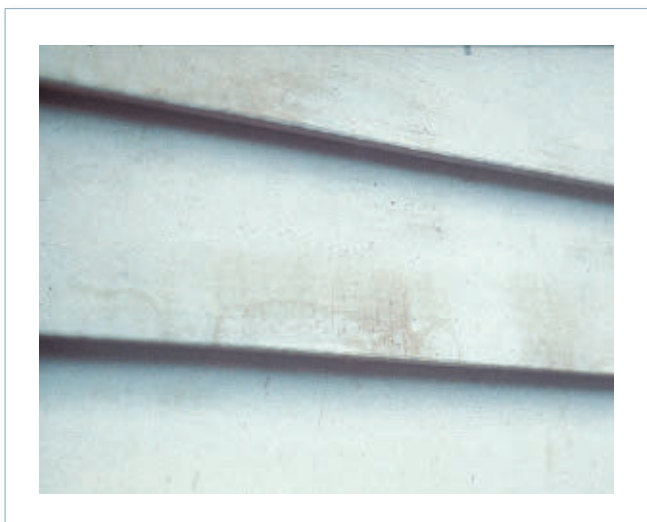
Figure 1—Diffused extractive bleed.

- Diffused discoloration of paint (*Figure 1*) typically results from penetration of the paint film by water or water vapor. This diffused discoloration usually occurs in the first few cycles of wetting or high humidity after paint application and can be attributed to a porous or thin paint coat that is insufficient to prevent water penetration. The water present as the carrier in waterborne finishes can also cause diffused discoloration. In these cases, discoloration is evident at the time of coating application, even before the coating has dried. Traditional stain-blocking primers were formulated with oil alkyds, which have proven to be best in preventing extractive bleed when applied as the first or primer coat. Recently, coating manufacturers have formulated waterborne stain-blocking primers to comply with regulations restricting solvents in paint. The waterborne systems do not work as well as traditional oil-alkyd-borne formulations, but manufacturers continue to improve them.

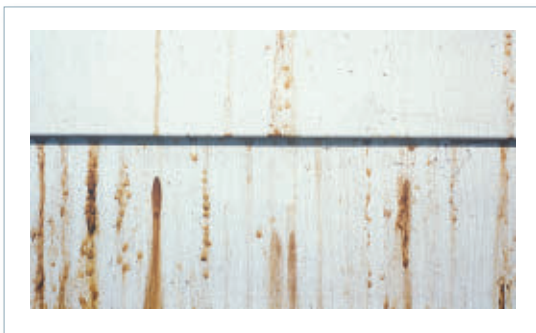
Figure 2—Run-down extractive bleed.

- Run-down or streaked type of extractive bleed (*Figure 2*) indicates that water has gained access to the back side of the siding. This can be caused by washing the wood with high-pressure washers, condensation of water vapor, leaks from improper flashing or building paper use, wind-blown rain behind the siding, or open joints in the wall that permit rainwater intrusion. In the case of siding that has not been end-primed after having been cut to fit around door and window openings, rain can cause this run-down form of extractive bleed. Rainwater easily soaks into the unsealed end grain of the siding where it dissolves extractives in the wood (*Figure 3*). These forms of stain are best prevented with good building practices.

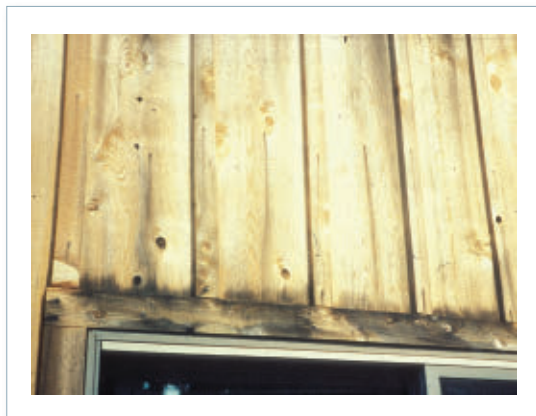
Figure 3—Extractive bleed from end-grain absorption of water. Note the fasteners have also caused iron staining.

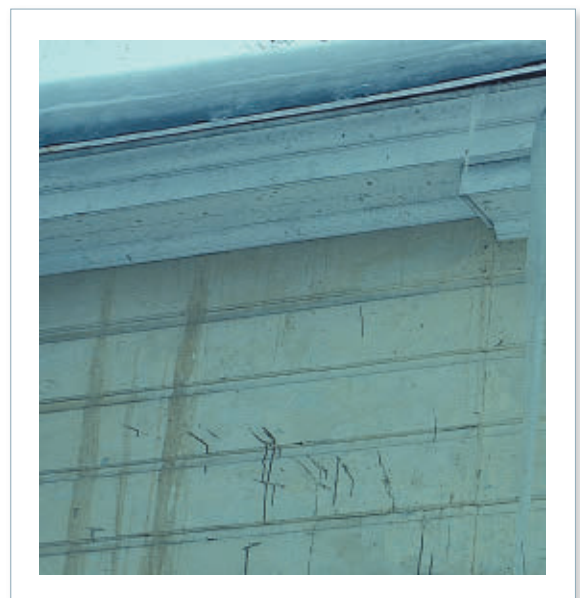
Figure 4—Ice dam on roof and gutter. The resulting water intrusion into the wall and behind the siding often causes run-down extractive bleed.

- Ice dams on roofs can cause water to overwhelm drains and gutters and flow behind rake boards, soffits, fascia, and siding, causing extractive bleed (*Figure 4*).

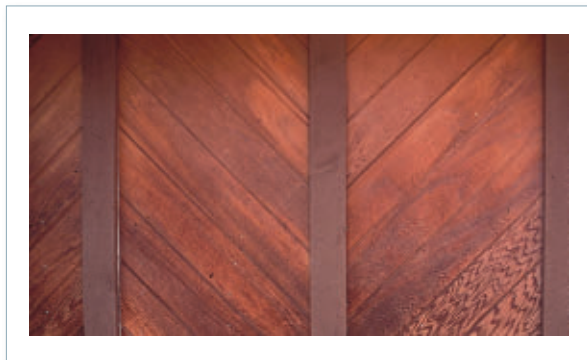
Figure 5—Uneven extractive bleed on siding.

- Unfinished wood that is allowed to weather naturally may take on various colors from extractives migrating to the surface (*Figure 5*).
- Initial MC of wood at the time of installation can contribute to extractive discoloration of coatings if the builder fails to acclimate the wood before it is installed. Unfortunately,

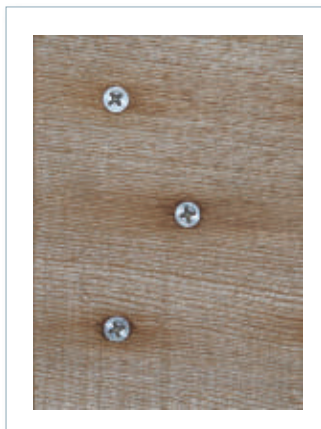
Figure 6—Extractive bleed around stainless steel fasteners.

- Nails and other fasteners damage wood, and water absorbed into these damaged areas may result in localized extractive bleed near the fasteners (*Figure 6*). This type of extractive bleed is minor and usually disappears within a few weeks. It should not be confused with blue-black iron stain, which is caused by the chemical reaction between iron leaching from low-quality fasteners and tannins in the wood (*Figure 7*). Tannins are one of many WSE and are found in high concentrations in several commonly used wood species (redwood, many cedars, oak). Minute amounts of iron cause this type of discoloration, and it is extremely difficult to remediate. Although the unsightly blue-black stain can be neutralized with aqueous oxalic acid solution, it will reappear if the source of iron—typically an inappropriate fastener—is not removed. If improper fasteners were

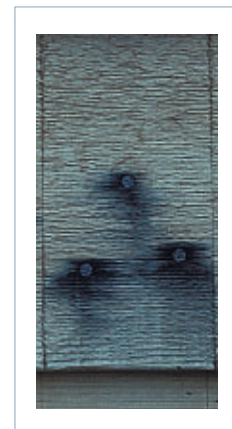
Figure 7—Iron stain around electro-plate galvanized fasteners.

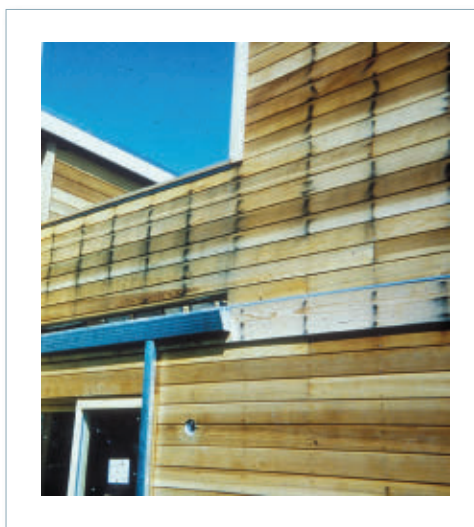
Figure 8—Iron stain on newly constructed home. The intent of the owner was to have a natural finish (lightly pigmented semitransparent stain) on the siding. To correct this, the siding will need to be replaced.

used to fasten siding to a structure, fixing this is almost impossible (Figure 8). The only long-term solution is to replace the siding—an expensive fix caused by careless selection of fasteners. Use of stainless steel fasteners or consulting with the wood supplier for recommendations regarding fastener choice will help avoid this problem.

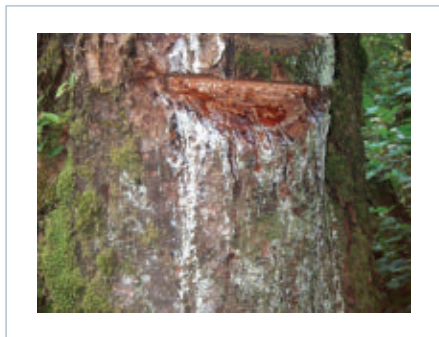
Figure 9—Pitch bleed from a cut on a tree.

of the wood and is particularly common over knots. Pitch and other resins are a defense mechanism that a tree uses to protect itself from harmful pathogens and insects following injury. When a tree's bark is damaged, pitch flows into these areas to protect the wound (Figure 9). Pitch also exists as a normal part of the wood of pines (*Pinus* spp.), spruces (*Picea* spp.), larches (*Larix* spp.), and Douglas-firs (*Pseudotsuga* spp.), and can be found in specialized wound structures called pitch pockets in the wood of most softwood species. Chemically speaking, pitch is a solution of natural rosins and turpentine. Although pitch is an SSE, it exudes from wood by bulk flow without solvent extraction.

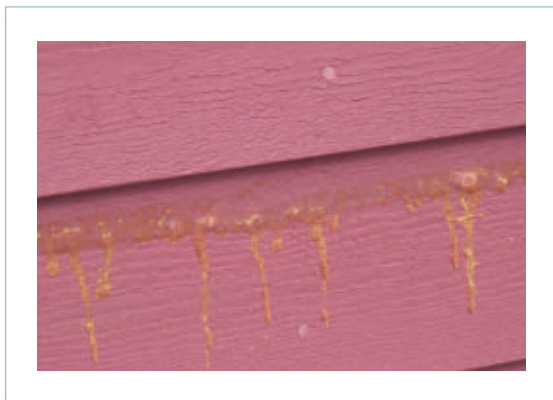
Figure 11—Large pitch pocket or seam.

If wood exhibits pitch bleed, there are several ways to remove the pitch depending on how fluid it is. If the pitch has not hardened (that is, if it still contains enough turpentine), it can be removed by dissolving it with turpentine or mineral spirits. Once it has hardened, it can be removed fairly easily with a putty knife, paint scraper, or sandpaper. If the pitch is still soft, such procedures smear it over the surface of the wood and paint. If the pitch cannot be easily dissolved with mineral spirits, it is probably best to let it harden and scrape it off. It may be possible to set small amounts of pitch by heating the wood with a heat gun, but this probably will not work for large pitch pockets, such as shown in *Figure 11*, or those located deep in the wood.
